JHIS
Johnson Home Inspection Services LLC
License# 450.0001341
5133 Brookstone Dr. Rochelle IL 61068
815-441-1275

INSPECTION REPORT

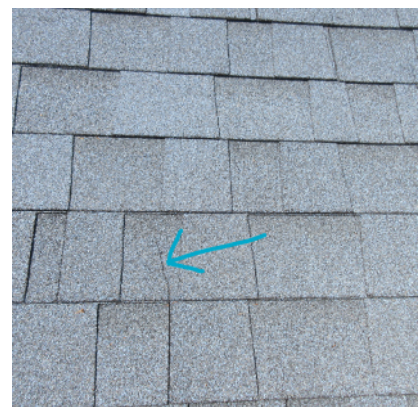
I inspected the roof by walking on the roof. It is an architectural composite shingle with about a 25 year warranty. It is difficult to know for sure, it looks to have about 3/4 of its expected life left. The pitch was about 4-12. There was one visible layer of shingles. The roof was in good condition. There were 5 or 6 shingles that had these cracks. They are over seams of shingles below them. They are caused by inadequate

ventilation. They should be replaced. They are above the vaulted ceiling area. Most were on the the street side of the house. You should consult with a roofer about more adding ventilation to the roof.

1. Roofer replace the shingles with a crack in them and consult about the ventilation.
2. Fix the piece of loose siding.
3. Plumber check the sink drain in the kitchen. Ask about some of wax ring showing.
4. An electrician to install GFCI outlets where needed. Install cover on outlet in garage. Put wires in conduit or wire mold. Ask about basement outlets not being grounded.

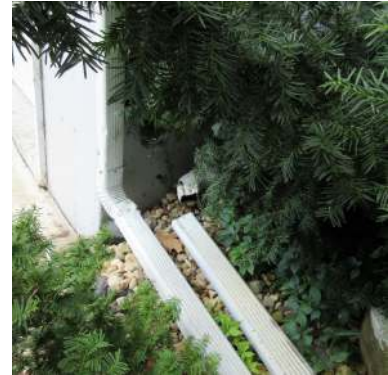
The gutters were in good condition. It is important to keep the gutters clean and properly working, because they help to keep water away from the foundation and out of the basement. Keep the extensions on the downspouts to move the water away from the foundation.

1. Make sure the extensions are on the downspouts.
2. Caulk around windows where needed.
3. Trim vegetation around the building.
4. Adjust down pressure on the overhead garage door.

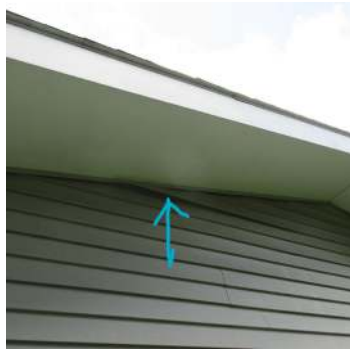
The exterior was vinyl siding. It was in good condition. There was one piece that the channel had separated. It should be locked together.

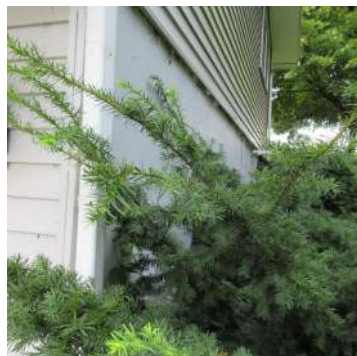
The grading is how the ground is pitched around the house. Ideally you want a drop of about 1/4" per foot for about 6'-10'. Proper grading helps to keep water away from the house. Most of the grading was O.K. except for the back. The back there is not much that can be done because of the lot. If water comes from the top of the hill and gets into the basement you could consult with a landscape contractor about a retaining wall.

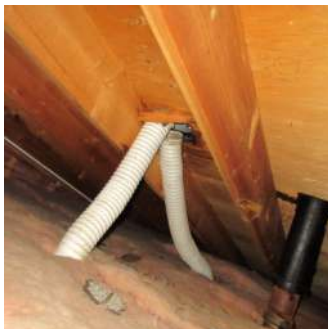
The attic space was in good condition. There was about 10" of insulation. It is recommended to have an R-43 Value which is about 14" of insulation depending on the type of insulation used.

The ducts for exhaust fans in the bathrooms were vented to a box vent in the attic.

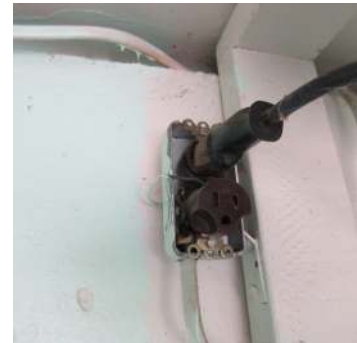
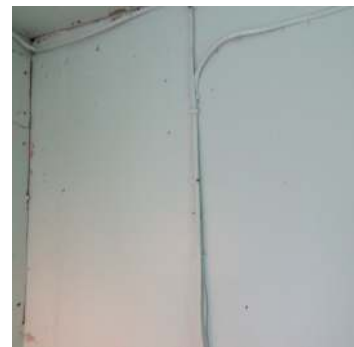
There were GFCI outlets in the upstairs bathrooms, kitchen, and outside. If the GFCI on the left side of the stove trips it also trips the one on the right side. Both will have to be reset. The GFCI outlet in the half bath also trips the main bathroom GFCI. They will both have to be reset. The garage did not have GFCI protected outlets. GFCI outlets are used within 6' of wet areas for safety. The outlets in the basement were not grounded. That could be a shock hazard. You might want to consult with an electrician about that. About the wires for the fans that are in chains. I could not find anything that states that is not allowed. The other thing you could do is use wire mold to put the wires in. In the garage there is an outlet without a cover. A cover should be added. The wires in the garage are exposed and that is not code. They should be in conduit or wire mold.
